Device Errata

Skywire[®] Raspberry Pi Adapter

NimbeLink Corp

Updated: July 2017

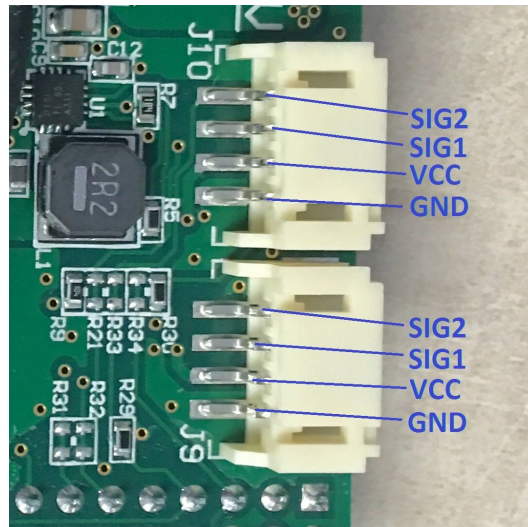
Applications using the Grove connectors on NL-AB-RPI adapter board with PCB revision 1001430 REV A are affected. The grove connector pins are reversed, as shown in the image below. Users who wish to use Grove sensors on affected PCBs must follow the steps outlined in section four of this errata.

The suggested workaround is to modify the Grove sensor cable connector to allow it to be plugged into the adapter upside down. Users will need to remove the polarity tabs from the Grove connector on the cable. To remove the tabs follow these steps:

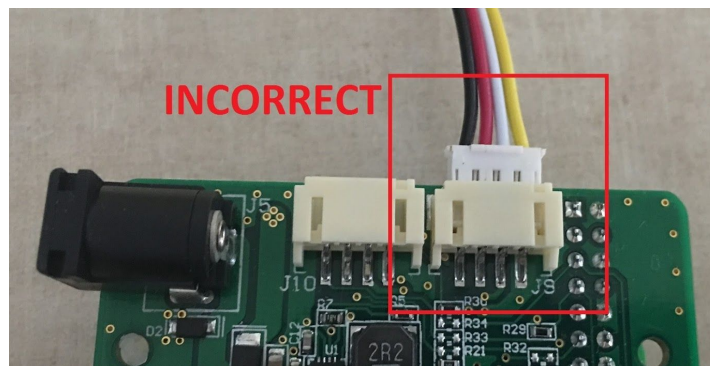
Grove sensors using unmodified cables should not be directly attached to the Grove connectors on affected boards as this may cause shorts and/or damage to the sensor or Raspberry Pi.

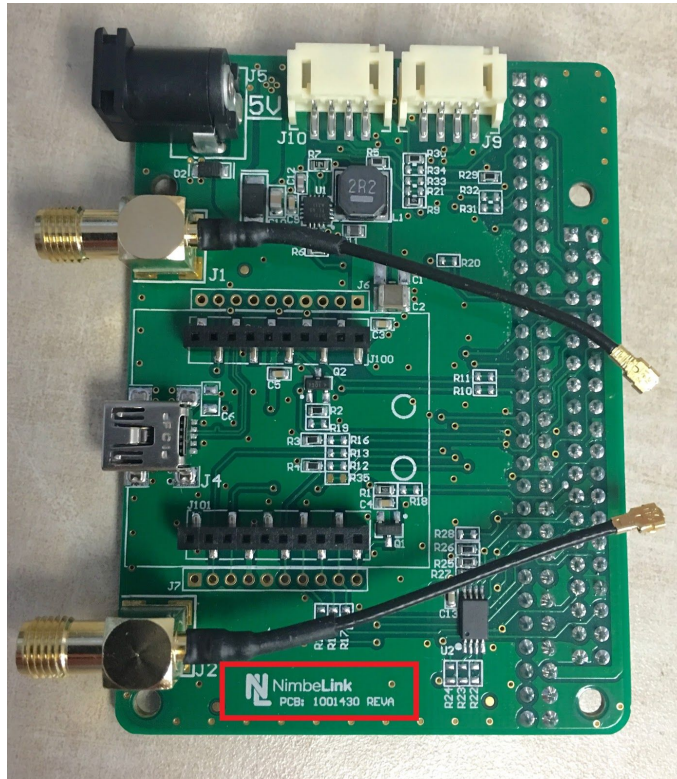
The PCB revision number is located on the bottom of the top side of the PCB. This Errata affects all NL-AB-RPI boards with a PCB revision number of 1001430 Rev A.
