Device Errata

Skywire™ Raspberry Pi Adapter

NimbeLink Corp

Updated: July 2017

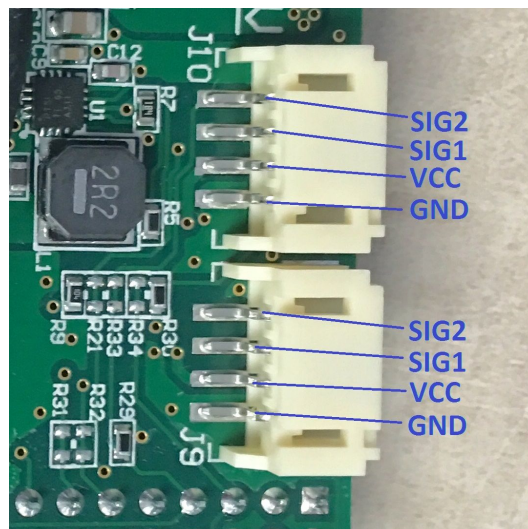
Applications using the Grove connectors on NL-AB-RPI adapter board with PCB revision 1001430 REV A are affected. The grove connector pins are reversed, as shown in the image below. Users who wish to use Grove sensors on affected PCBs must follow the steps outlined in section four of this errata.

The suggested workaround is to modify the Grove sensor cable connector to allow it to be plugged into the adapter upside down. Users will need to remove the polarity tabs from the Grove connector on the cable. To remove the tabs follow these steps:

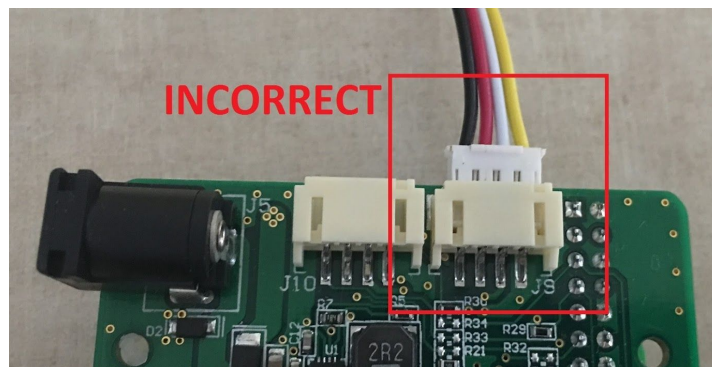
Grove sensors using unmodified cables should not be directly attached to the Grove connectors on affected boards as this may cause shorts and/or damage to the sensor or Raspberry Pi.

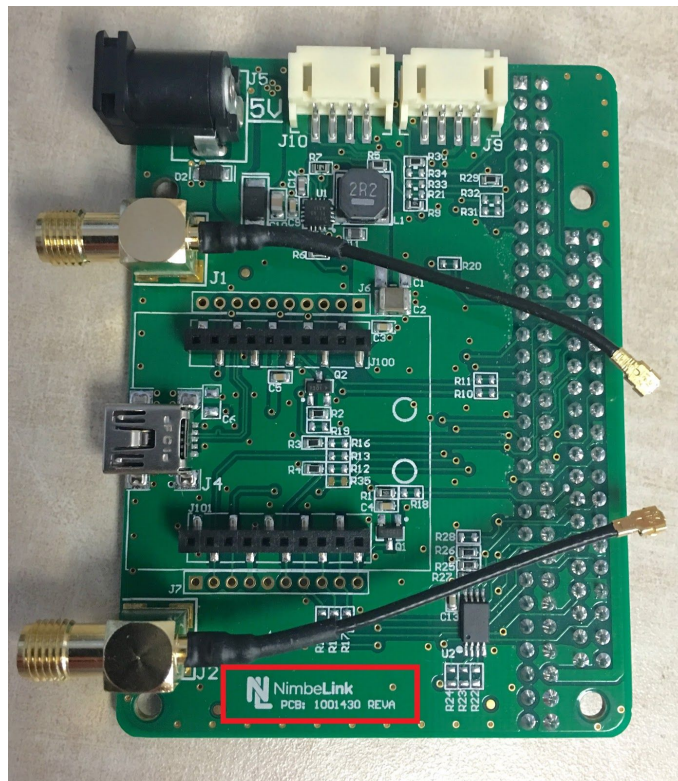
The PCB revision number is located on the bottom of the top side of the PCB. This Errata affects all NL-AB-RPI boards with a PCB revision number of 1001430 Rev A.
