Device Errata

NL-SW-HSPA Skywire[®] Modem

NimbeLink // Products
Published // May, 2018

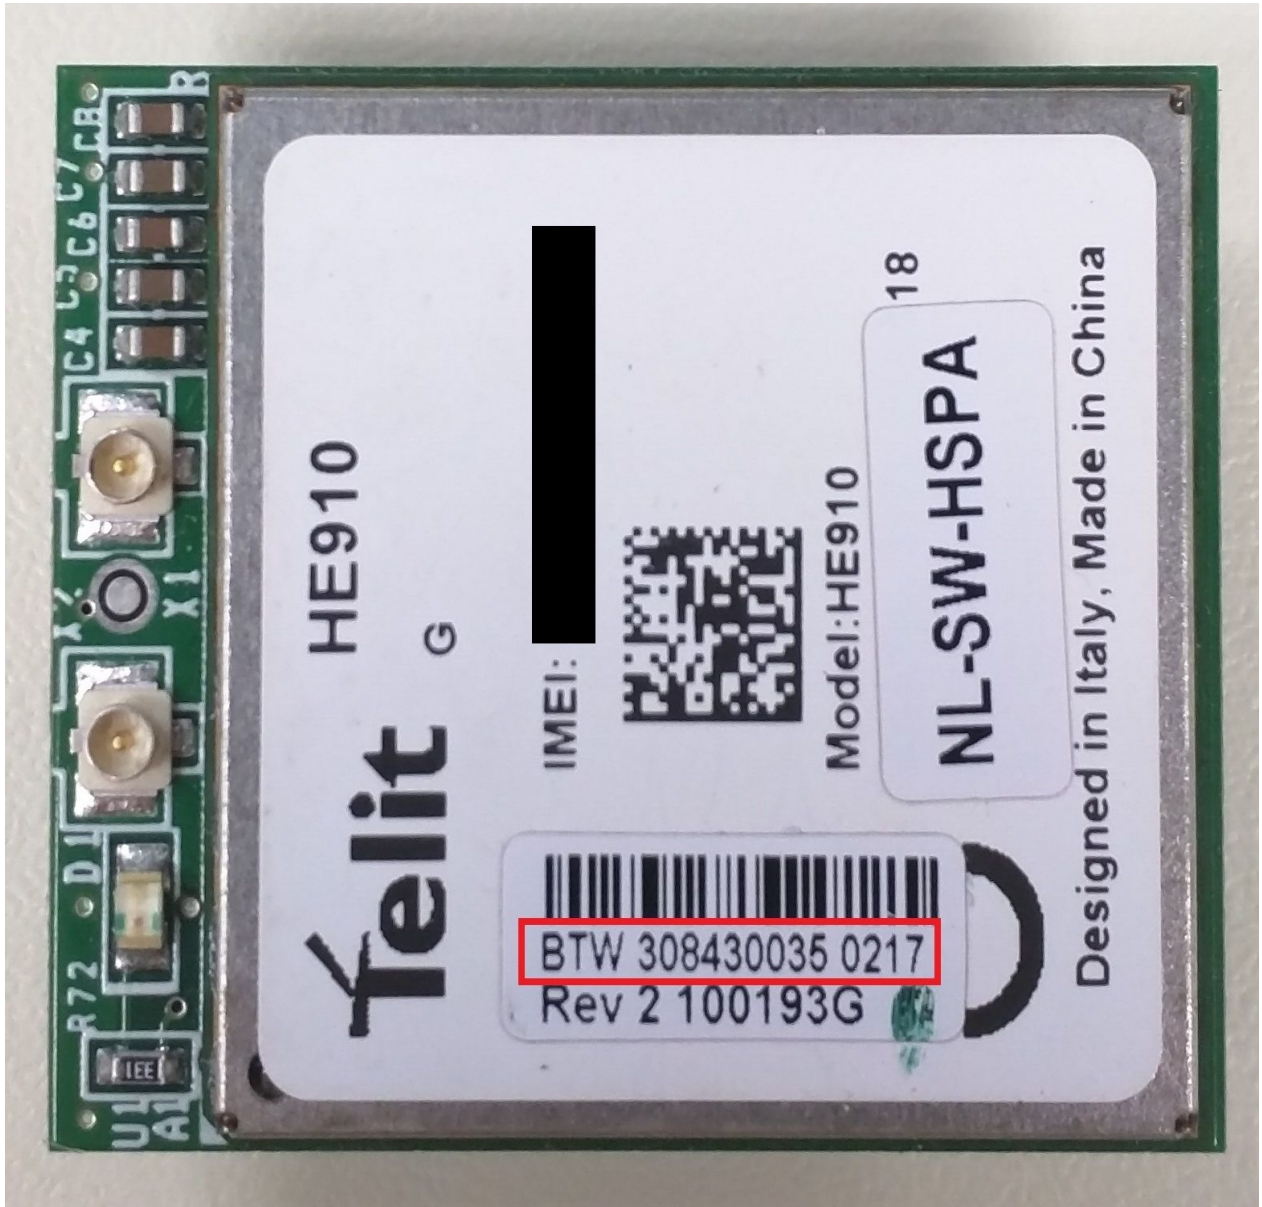
To determine if an NL-SW-HSPA modem is affected by this error, please locate the serial number starting with “BTW” on the label attached to the top of the device. If the first 9 digits of the serial number lie in the range: BTW 308430001 through BTW 308430589, then the modem is affected.

Figure 1: The location of the serial number.

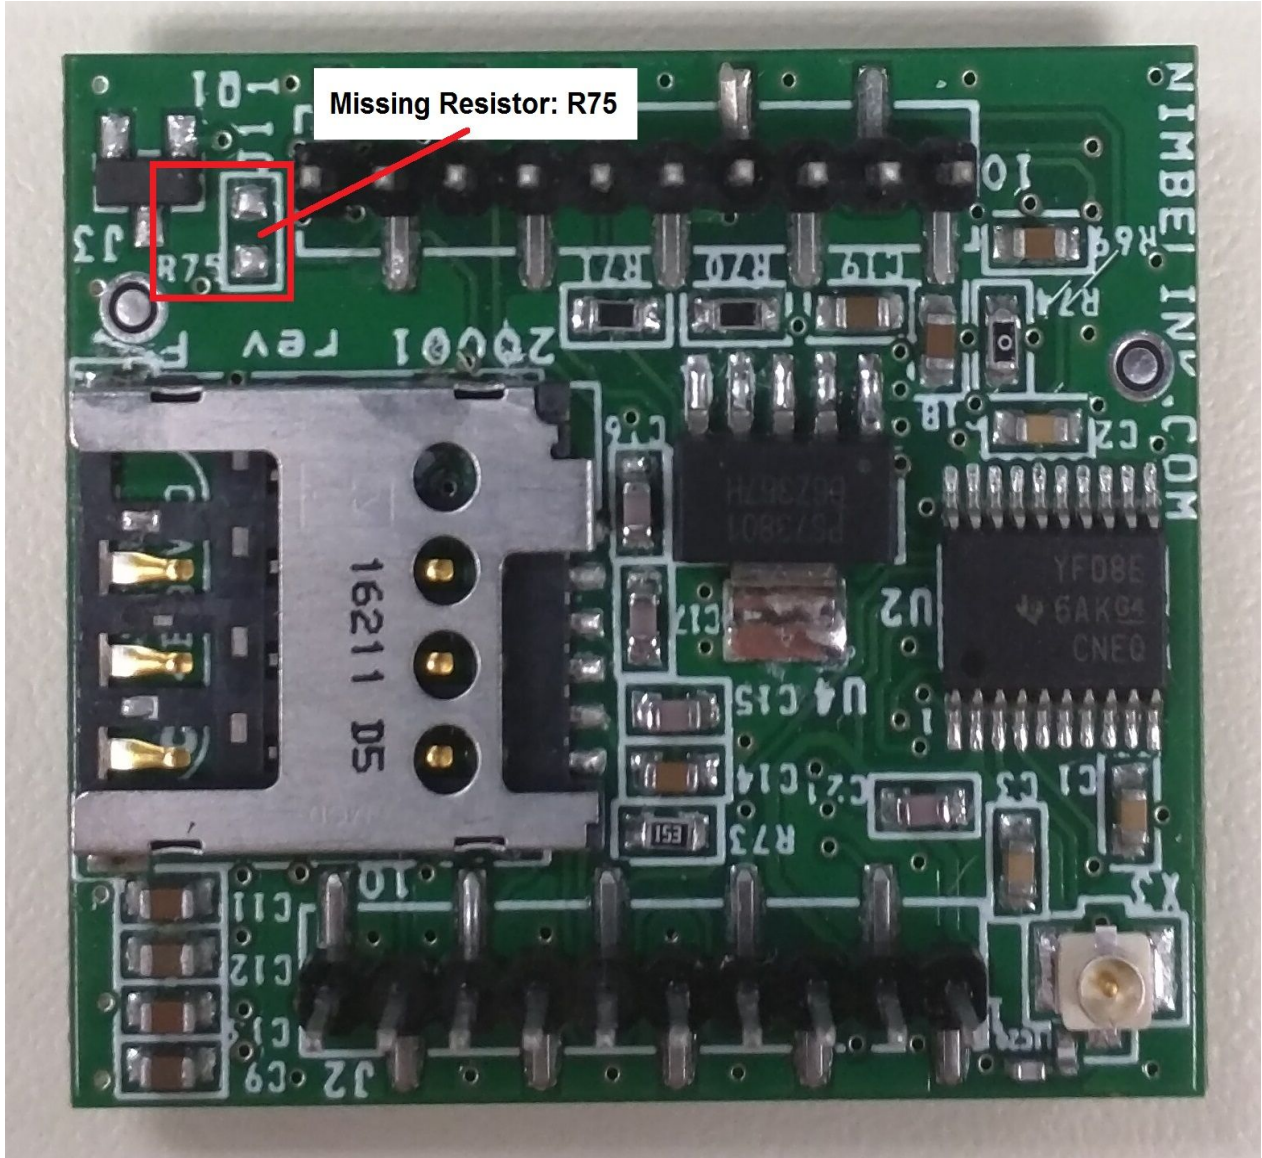
This errata addresses an issue involving SIM card detection on specific NL-SW-HSPA modems. On affected modems, the resistor R75 is missing from the modem PCB assembly, which causes the modem to think the SIM card is not present.

Figure 2: The location of the missing resistor, R75.

When resistor R75 is missing, the module's SIMIN pin is not tied to the correct state and the modem thinks the SIM card is not present. One workaround is to use an AT command to force the modem to think a SIM is present, independent of the external SIMIN state. This can be accomplished by issuing the AT command:

```
AT#SIMDET=1
```

Please note that this command must be issued each time the modem is restarted.

Alternatively, the modem can be returned to NimbeLink for repair. Feel free to contact us at product.support@nimbelink.com to request an RMA number.
