Device Errata

NL-SW-LTE-SVZM20

Skywire[®] Modem

Updated: January 2021

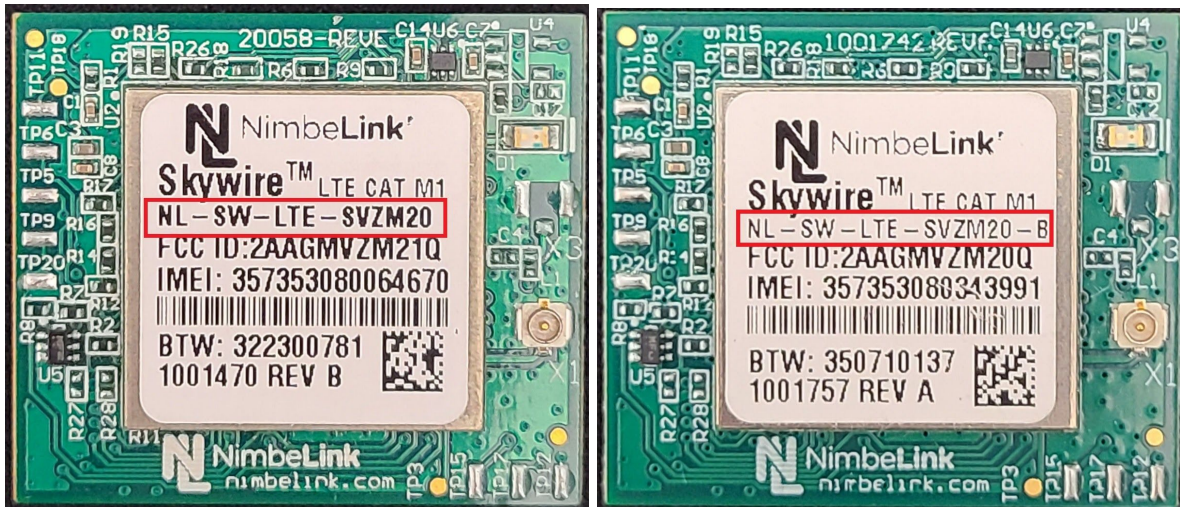
This Errata affects all NL-SW-LTE-SVZM20-x modems. Sequans firmware does not support Verizon FOTA using the LWM2M client. As a consequence, all devices must locally disable the LWM2M client using the procedure documented in Section 4 to prevent excess data usage and to prevent the device from being disconnected from the network.

All NL-SW-LTE-SVZM20 and NL-SW-LTE-SVZM20-B devices are affected. Affected devices can be identified by checking the part number on the modems label as shown in the example images below.

All users and devices must disable LWM2M by issuing the AT command sequence shown below to the modem. This will disable the LWM2M client after reboot. This setting is persistent after reboots but is not persistent after a factory reset.

This product is end of life and no firmware updates to correct this action will be implemented. Customers must apply the work around or migrate their design to use the NL-SW-LTE-QBG96 or NL-SW-LTE-QBG95 Skywire modem.
